Re: Report on Hipson Brook Bridge Site Investigation (Project No. 10-22010-038)

Hipson Brook Bridge is a stone masonry arch bridge spanning the Hipson Brook in East Pubnico, Nova Scotia. The bridge was originally constructed as part of the original Nova Scotia Truck #3 Highway in the early 1900's. The bridge has only been subjected to pedestrian loading since 1936 when the original highway was realigned and a new bridge was constructed upstream from the existing.

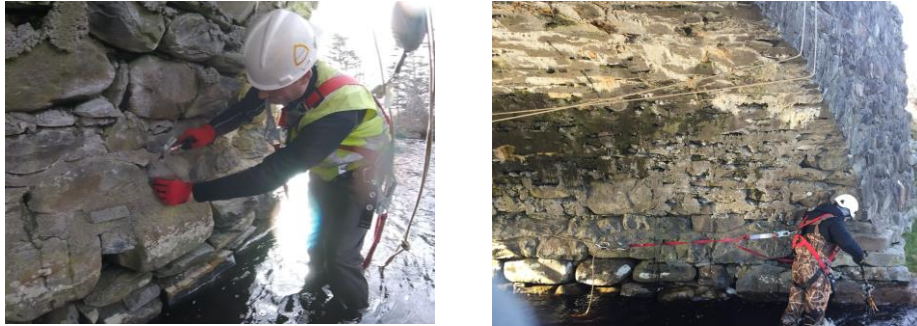
Figure 1: Testing of mortar deterioration (Left), Underwater video of arch foundations (Right)

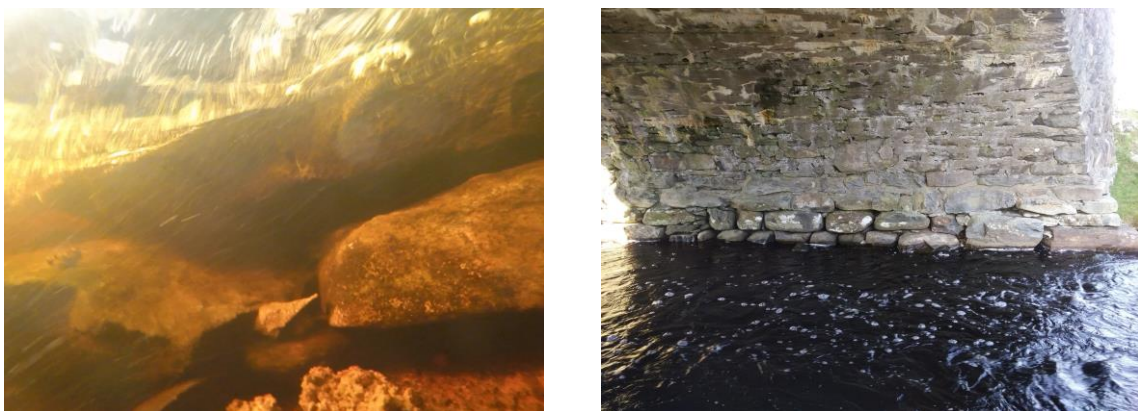
1. Undermining of foundations due to the brook flow;
2. Large fractured rock in north abutment/foundation;
3. Mortar at or below water line is badly deteriorated or absent due to the brook flow;
4. Previous patch repair of mortar on arch soffit is inconsistent with historic structure, covers the faces of stones, and is deteriorating;
5. Signs of widespread water seepage from top of arch is visible on arch soffit as evidenced by efflorescence;
6. Mortar on outer faces of bridge spandrel and parapet walls showing signs of deterioration;
7. Missing stones from parapet railings;
8. Stacked rock retaining walls on bridge approach are deteriorating, with rocks displaced or falling.

Figure 2: Loss of mortar in north foundation (Left), Condition of arch soffit (Right)

1. Foundation:
 - a. Replace fractured/fragmented stones;
 - b. Pressure grout foundations below water line using appropriate grout material;
 - c. Point masonry joints.
2. Foundation Above Water and Arch:
 - a. Remove previous mortar patch repairs and original mortar to 50 mm depth and repoint;
 - b. Excavate existing backfill to expose arch extrados and pressure grout from top of arch to fill voids created by loss of mortar and water seepage;

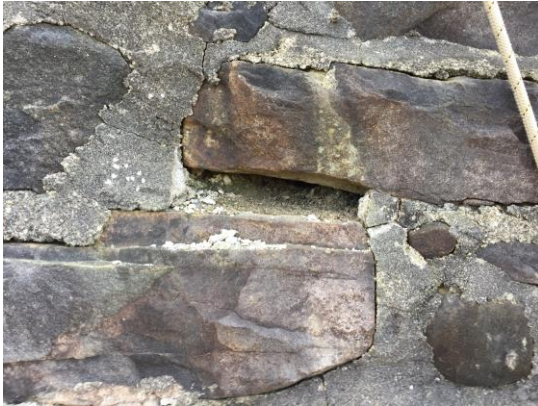
Figure 3: Deteriorating mortar on SE spandrel wall (Left), Presence of efflorescence on arch soffit (Right)

- c. Cover arch extrados with liquid waterproofing membrane and drainage board to prevent future water seepage and root ingress.
3. Spandrel Walls and Parapets:
 - a. Remove existing mortar to the depth of 50 mm from exposed and covered faces and repoint;
 - b. Replace missing railing stones.
4. Approach:
 - a. Reconstruct stacked rock retaining walls.
5. Landscaping:
 - a. Keep all community amenities as they are;
 - b. Reinstate any sod damaged by bridge repair work;
 - c. Add vegetation in front of bridge abutments to deflect water away from foundations (soil bioengineering measures);
 - d. Keep a grassy path to the water from the community park.

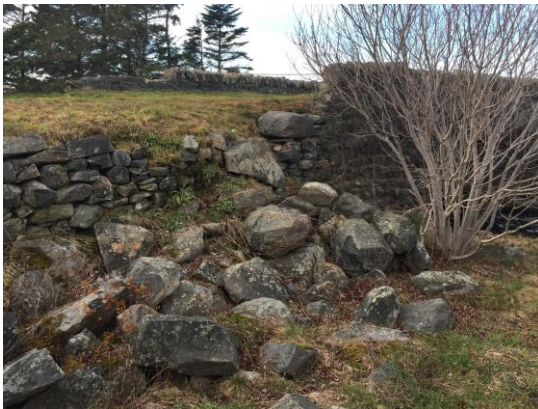
Figure 4: Partially tumbles south approach retaining wall (Left), Stones missing on west face of parapet railing (Right)

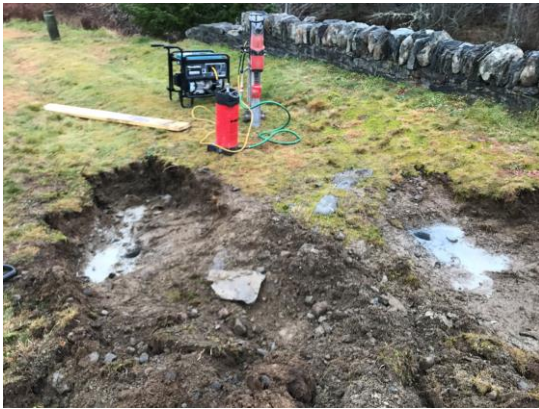
Figure 5: Masonry core extraction of arch (Left), Borehole drilling at north approach (Right)

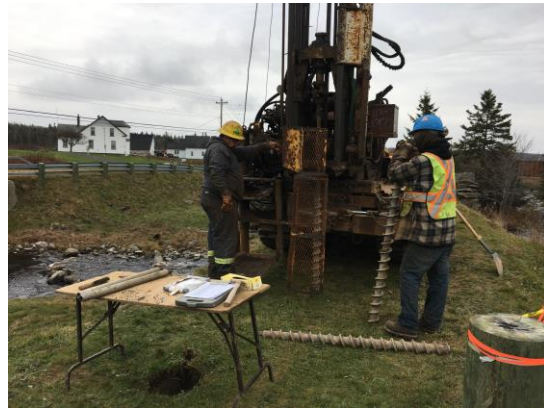
a. Strata underlying the bridge abutments is satisfactory and is not likely to lead to settlement of the foundation.

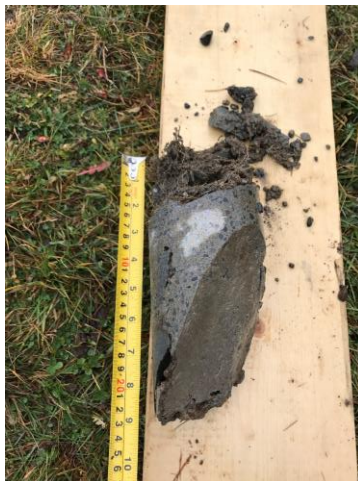
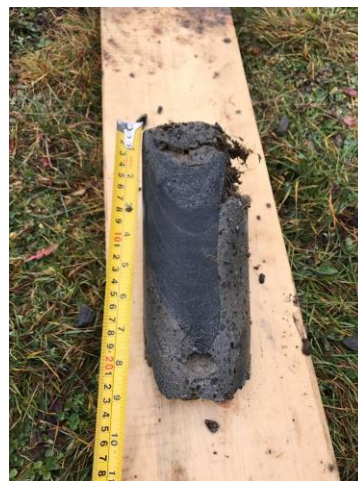
Figure 6: Extracted core samples from arch.

1. Masonry Core Extraction:
 - a. Fractures occurred at the interface of stone mortar/grout where surface water had seeped through, causing salt deposits and affecting the structural integrity of the arch;
 - b. Vegetation root ingress through cracks into the top layer of mortar was observed;
 - c. Presence of voids was noticed;

d. The arch appears to have been repaired in the past using cementitious material.
